Installation
Procedure for
GasPex Multilayer
with Double Leak
Detection Fittings

Contents

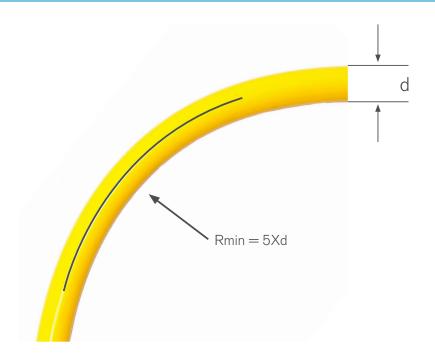
Step 2. Bending of the pipe

When bending the pipe the minimum bending radius is 5 x D where D is the nominal outside diameter of the pipe. Bending may be accomplished by hand with a internal or external bending spring or a copper tube bender.

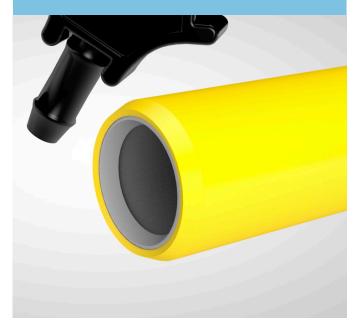
Step 3. Reaming of the pipe

The plastic and metal reamers perform 2 functions. The first function of the reaming tool is to round the pipe. The 2nd function of the reaming tool is to bevel the leading edge of the pipe to prevent damage to and rolling of the o-rings when the pipe is pushed on to the fitting.

There are 2 types of reamers available.
A plastic reamer as shown to the left or metal reamer shown below. The advantage of the metal reamer is the handle can be removed and it can be put in a drill for ease of use.

To ream pipe correctly, push the reamer fully in to the pipe rotating it as it is inserted. Rotate the reamer at least 2 full turns to bevel the edge and then continue to turn the reamer as it is withdrawn from the pipe. When correctly reamed, the pipe will look as pictured left.

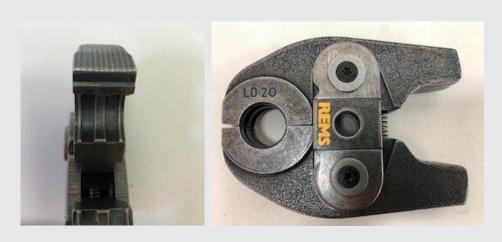
Step 5. Crimping of fitting

The Leak detect system requires a specific and unique pressing tong. The tong has the letters LD stamped on the face followed by the OD of the pipe that is to be used with. E.g. LD 20 - this is the tong for 20mm Leak detection fittings.

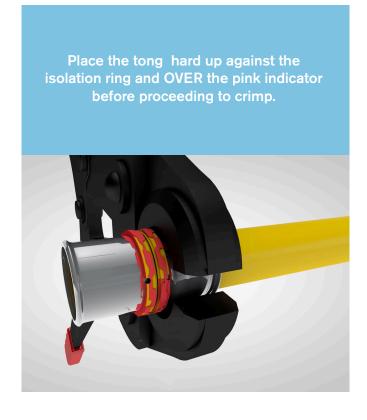
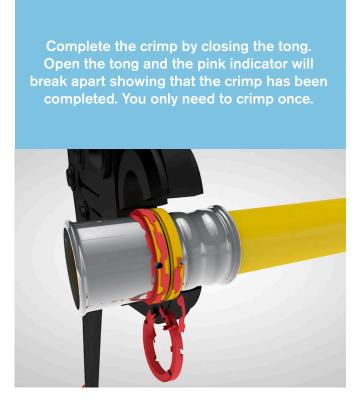
Ensure you are using the correct LD profile tong to crimp your leak detection fittings as pictured.

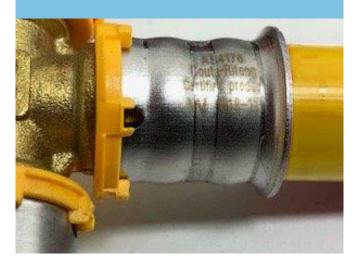
Step 6. Inspecting of the crimp

A successful crimp is when the pipe is visible in the witness holes, the pink indicator has broken away and you have 3 crimp lines as shown in the photo.

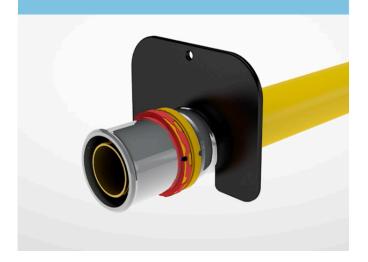
Check the crimp with the gauging tool.
The gauging tool should slide over the crimp and rotate without force. If this does not occur, the crimped joint has been insufficiently crimped and the tool may need calibrating.
Check correct calibration of the tool after the first crimp and after 60 crimps or at the start of each day.

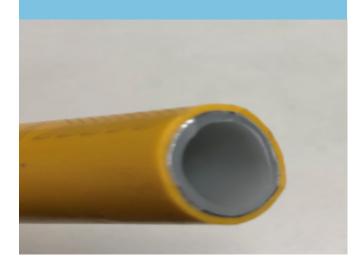
If the pipe is not reamed and beveled you will damage/and or roll the O rings when you push the pipe on to the fitting.
This will result in leakage of the joint.

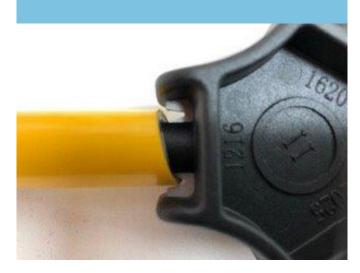
If the pipe isn't cut at 90 degrees then you will be unable to ream the pipe correctly. This will then result in the o-rings being damaged when you push the pipe on to the fitting. Damaged o-rings will cause leakage of the joint.

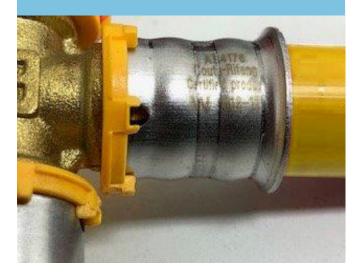
If the pipe is not visible through the witness holes this will likely result in leakage and/or total failure of the joint over time.

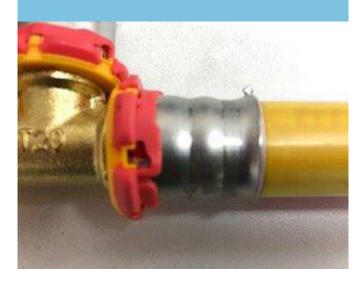
The pink indicator has not broken away after crimping which indicates that the tong has not been placed over the indicator ring during crimping. This will likely result in leakage and/ or total failure of the joint over time.
